MEMO

SUBJECT : Roadway Inspection Report

CIMA+ undertook a roadway inspection on Daniel Drive through the Resort Village of North Grove (RVNG) on June 27, 2022. The roadway was assessed considering several criteria including cross slope, embankment height, ditching, surface condition, and roadside features.

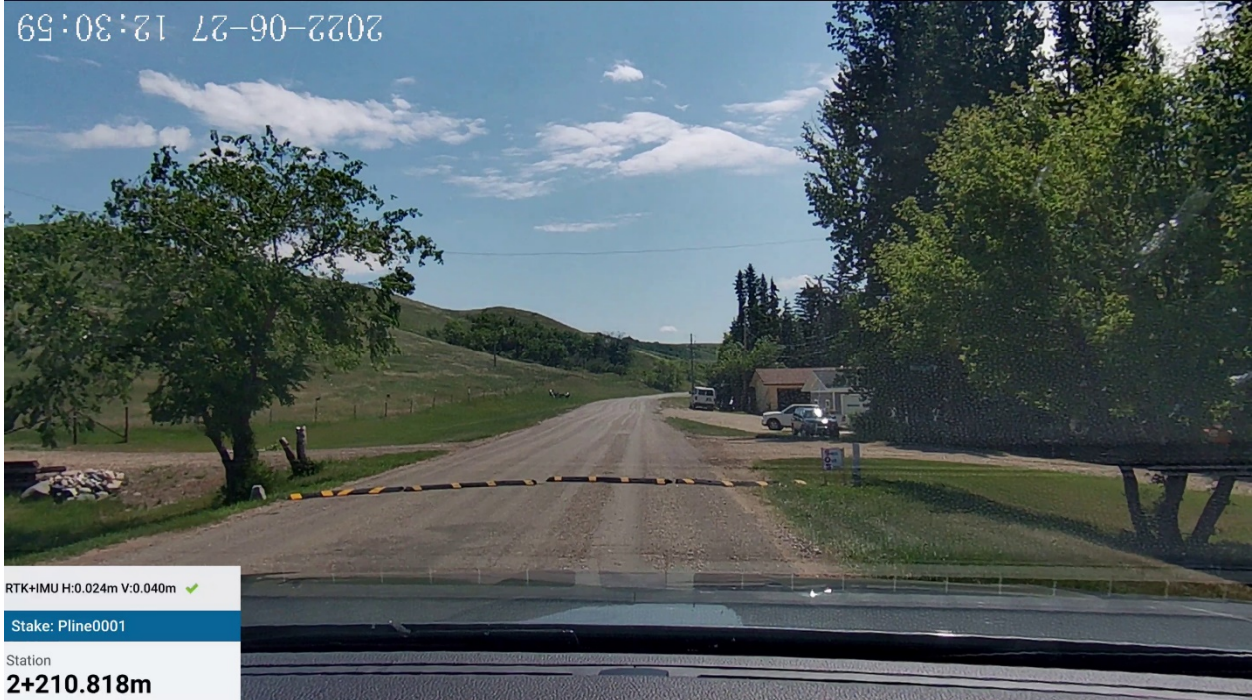
Figure 1 - Temporary speed bump that is recommended to be replaced by a permanent speed bump

Installation of permanent speed humps. Currently there are three locations where a temporary solution exists. Their placement appears to be near the entrance to the resort village, and then perhaps at problem areas. It may also be beneficial to install permanent speed bumps near either edge of the playground. This location is one of the flattest areas without curves and with a higher probability of pedestrian (mainly children) and vehicle conflict

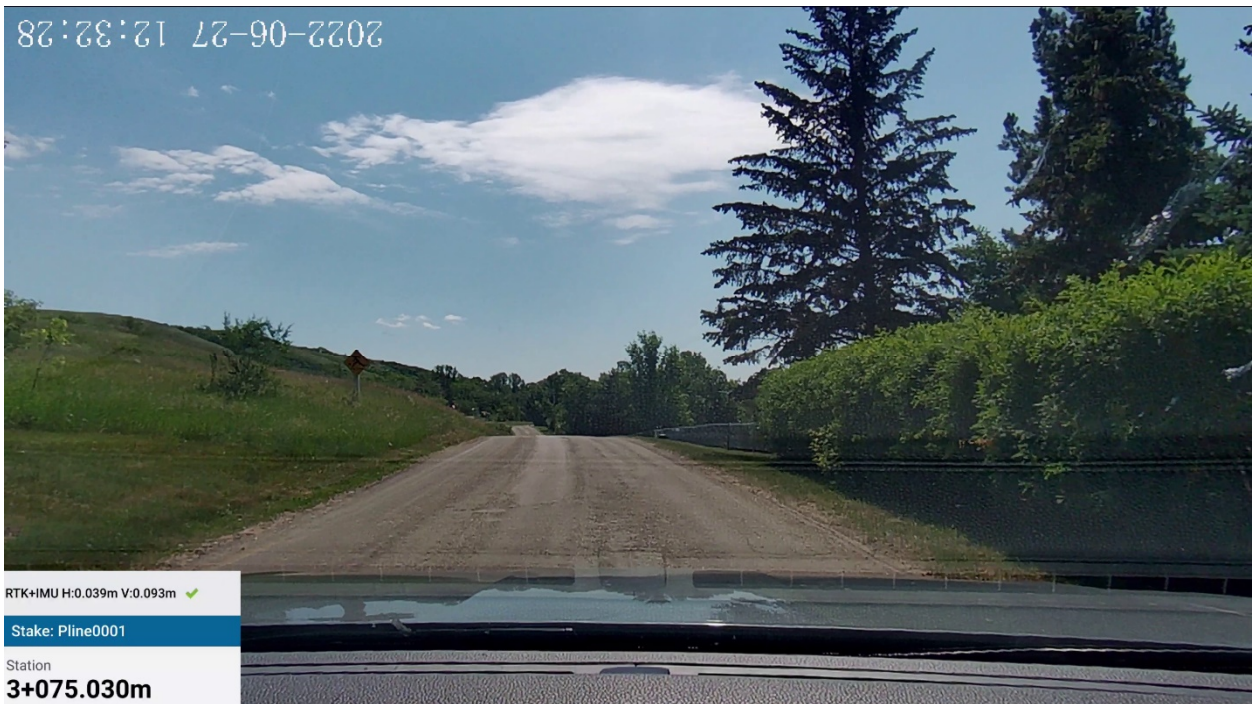
Figure 2 - Playground location, recommendation to have speed hump and signs located on the correct side of the road

There are several regulatory speed signs, as well as some warning signs throughout the roadway. The signs appear to be placed inconsistently and should be adjusted to achieve a more consistent flow. It was also noted that some signs appeared on the left side of the road rather than the right, which is not standard for a two-way road.

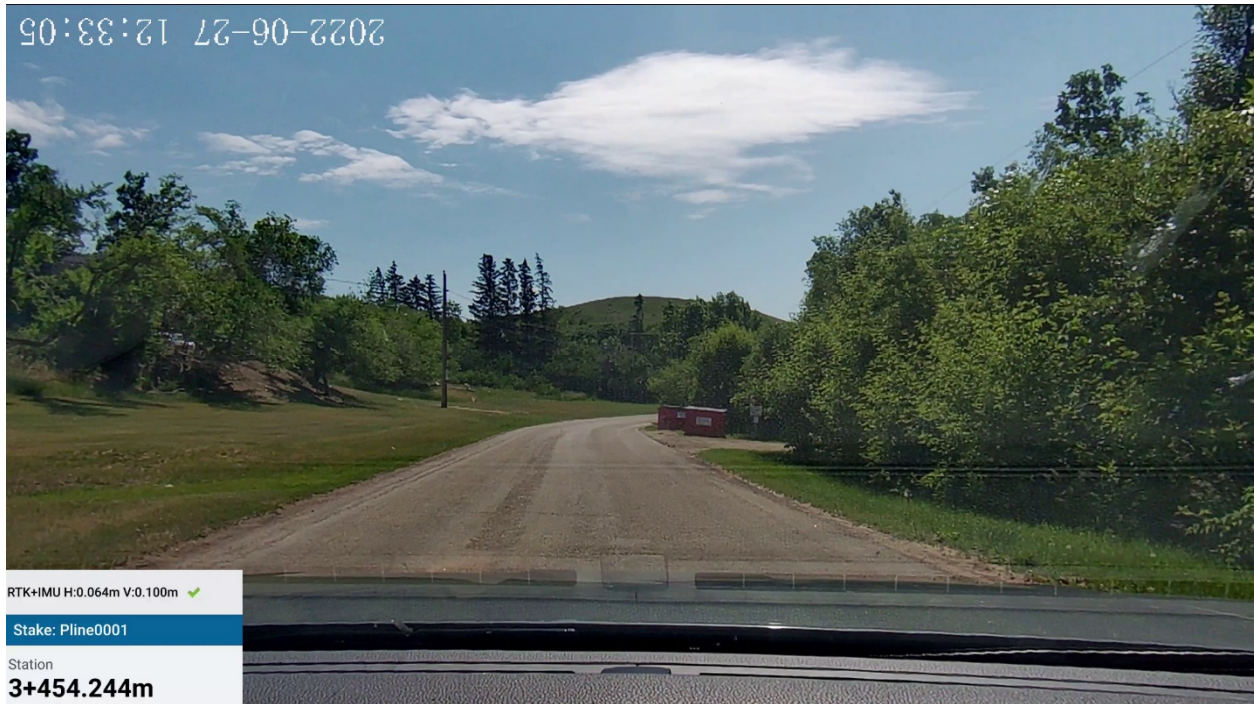
Figure 3 - Location of waste bins recommended to be moved on other side of the road to not obstruct roadway when being loaded/unloaded

Near station 3+500 there are two waste disposal bins that are situated just off the edge of the roadway. It would be assumed that when emptied, the waste disposal truck would be blocking the roadway. It is recommended that these bins be moved to a location where the roadway would remain clear. There is a flat area on the opposite side of the road that would provide adequate area for vehicles to stop to empty waste, as well as the waste disposal truck to load and unload the bins. Although not required, a gravel area of approximately 500 m² may provide a better experience if the weather is wet for both the residents and the waste disposal contractor.

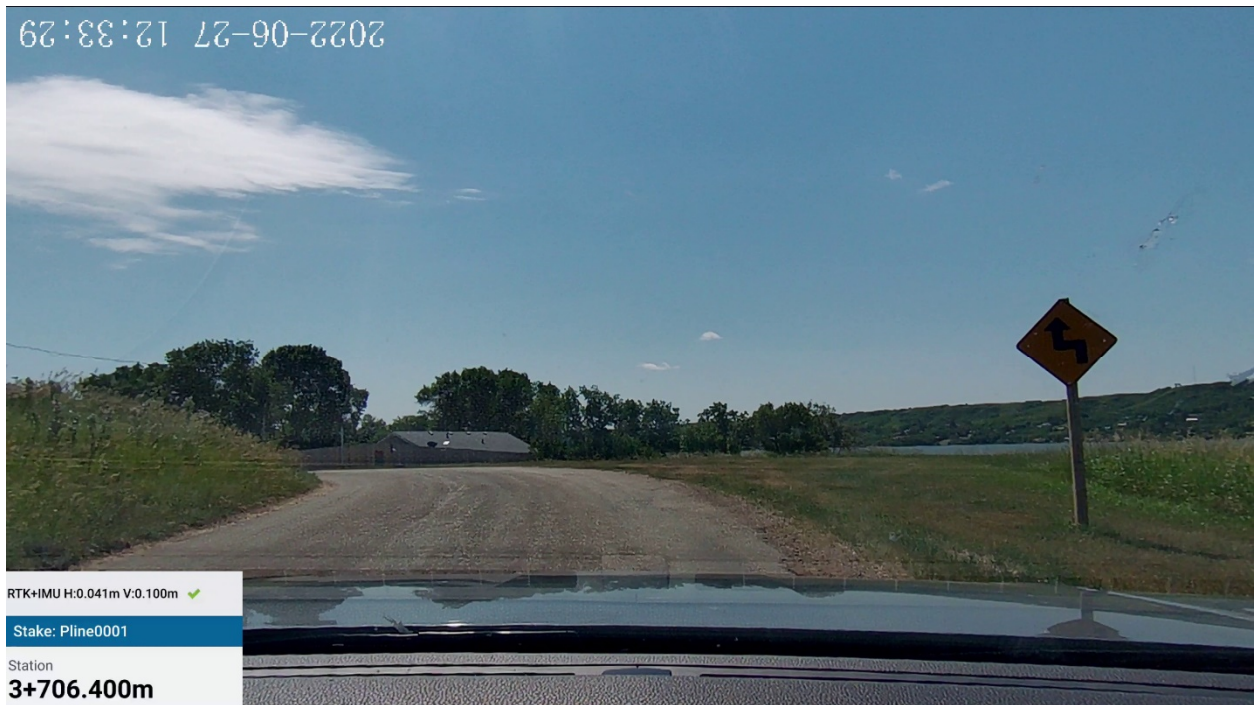
Figure 4 - Location where widening can occur with the addition of reflective poly posts

Where practical, some widening around tight curves would be recommended. The extremely tight radii present leave very difficult driving conditions for two vehicles meeting on the curves. With the roadway being of a substandard width in general, any additional width would greatly decrease the likelihood of a collision. In this case, a roadway widening would include some granular base with a seal coat to match the adjacent road.

Finally, installation of poly posts around some tight radii curves where there is adequate distance to the edge of the bank of the lake. These posts would be reflective in nature and aid night conditions, guiding motorists around the curve safely.

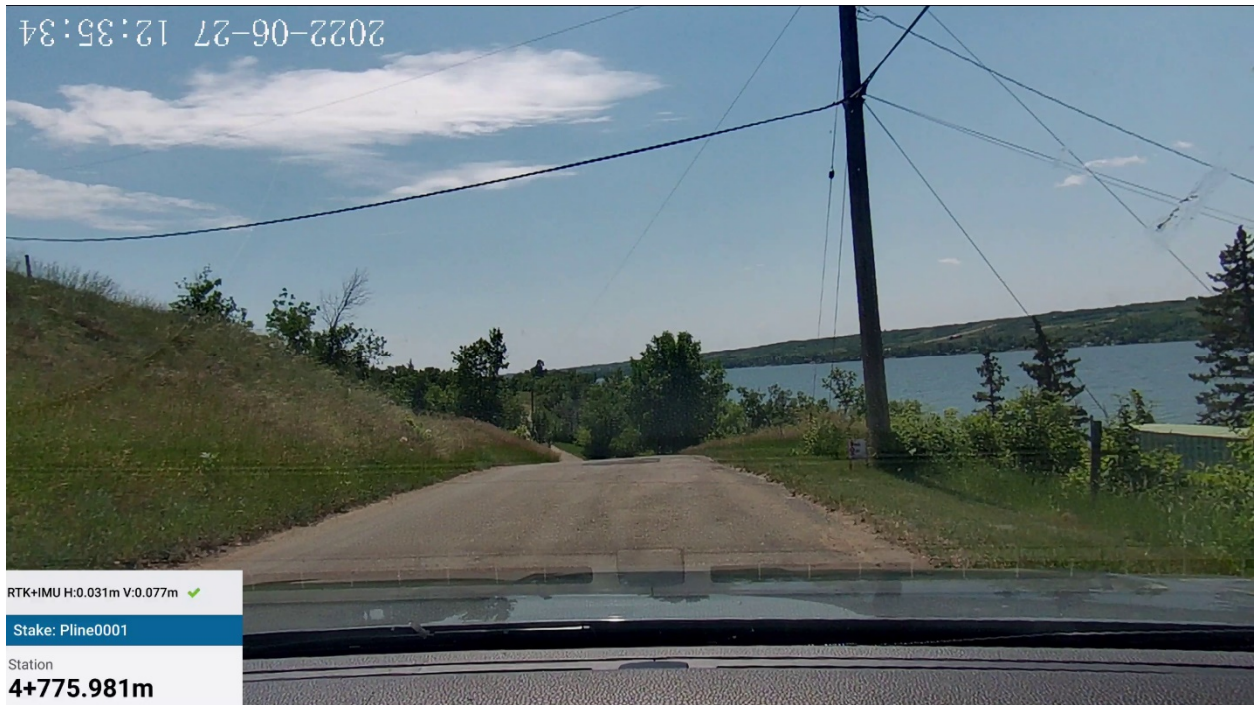
Figure 5 - Location of a low overhead power line, recommended that low clearance warning signs installed in both directions

There are several locations that have reasonable low overhead lines that may pose problems for delivery vehicles. With the construction of new homes in the Buffalo Vista development, larger loads of varying height may exist, at a minimum these should be signed accordingly, ideally raised if possible.

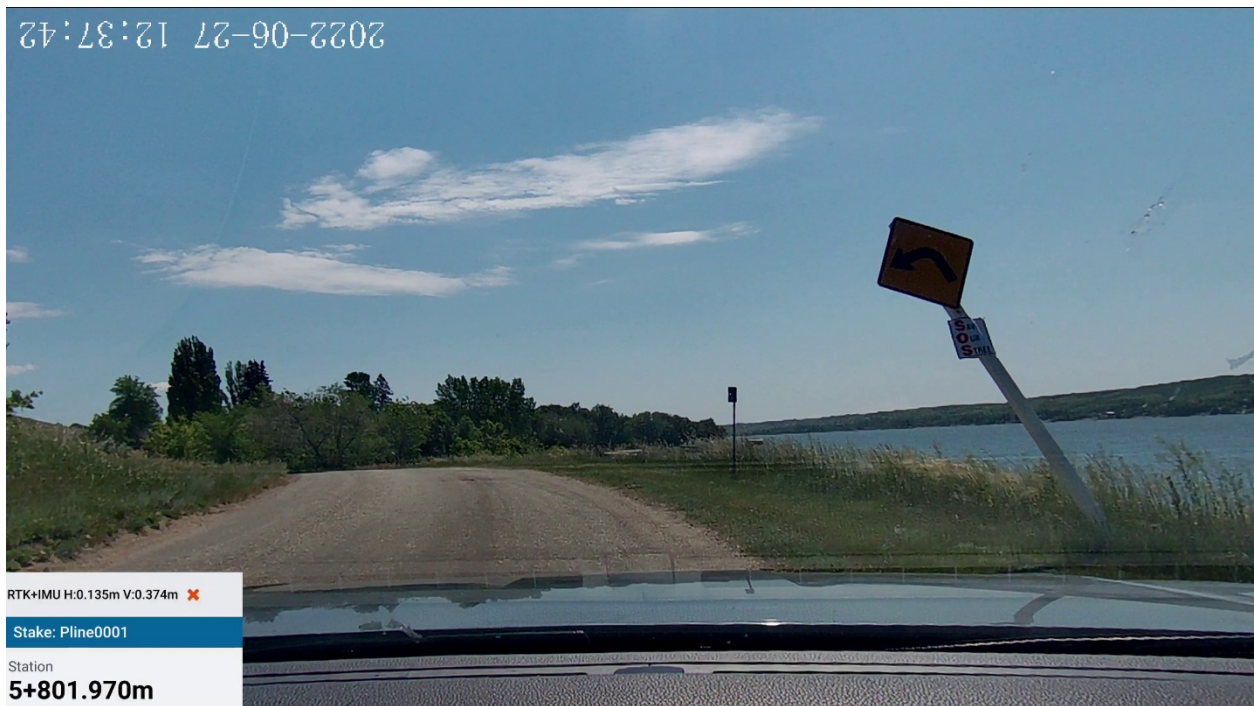
Figure 6 - Location where a slight widening and guard rail is recommended

The most immediate concern in respect to the roadway is the lack of guard rail at select locations. There are several locations with a steep drop off near the edge of the roadway. A w-beam guard rail is recommended in areas with steep drop offs on the edge of the roadway. A guard rail will increase the likelihood that a vehicle will remain within the limits of the roadway if it is headed astray.
